## 4-STAR TRAILERS - A WOLF IN SHEEP'S CLOTHING?

*Butch Patchell, Director of Research & Development, 4-Star Trailers, Inc.*

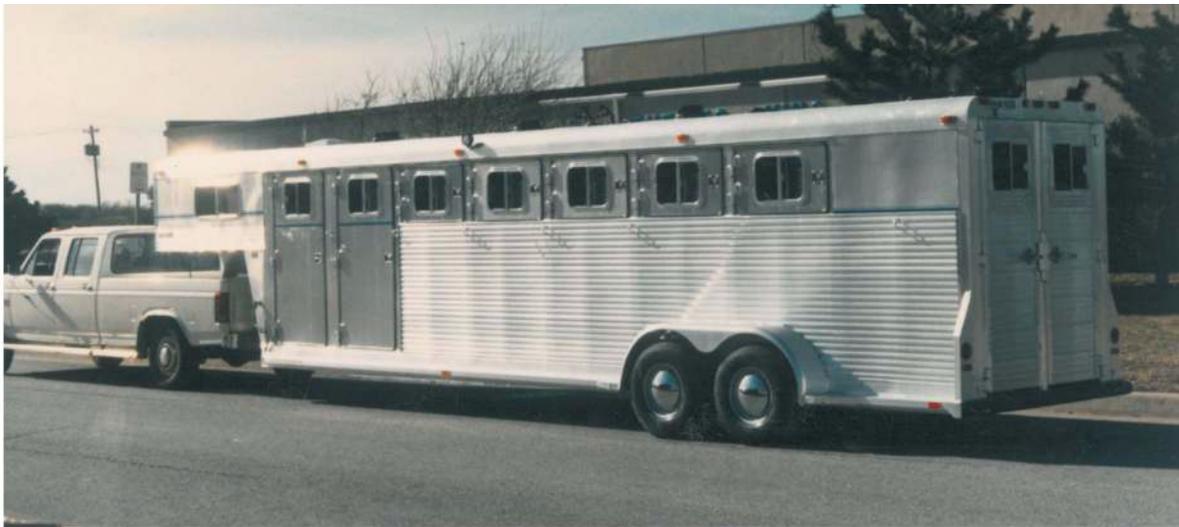
Fig. 1

The entire exterior of those trailers were rife with scars and distortions caused by the intense heat associated with welding. (See Fig. 1) The side walls were lined with corrugated slats that displayed the torture of MIG welds in the form of heat warps and burn throughs. The aluminum panels above the slats were covered in heat tracks where they were welded to the side posts.

We eliminated heat tracks in the slats and now our attention was directed toward the bare aluminum side skin panels. The welded skins were riddled with burn throughs and heat distortion which continued to be a major source of complaints.

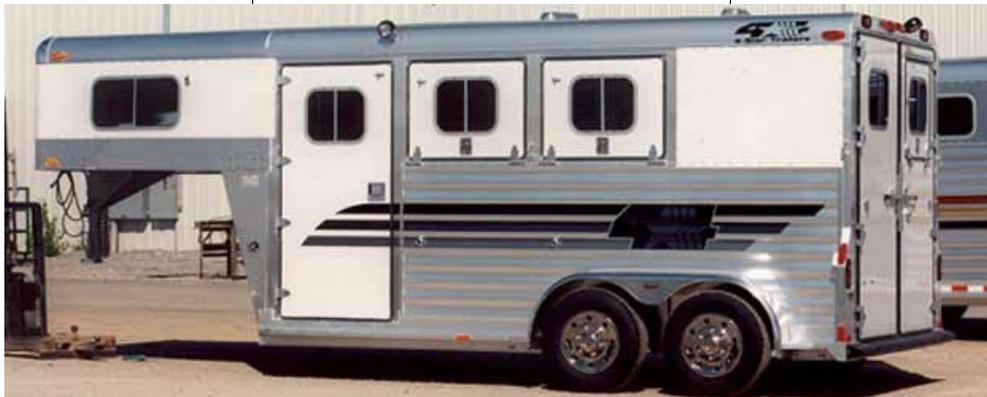
Fig. 2

At this time, the side skins overlapped the side posts around doors and windows leaving a large area of each post visible. (See Fig. 2) We needed this area of the side posts to be visible and accessible because we were still welding our door hinges to them. We didn't like the appearance of all this bare aluminum because we felt it now looked crude in contrast with the clean looking slats and side skins.

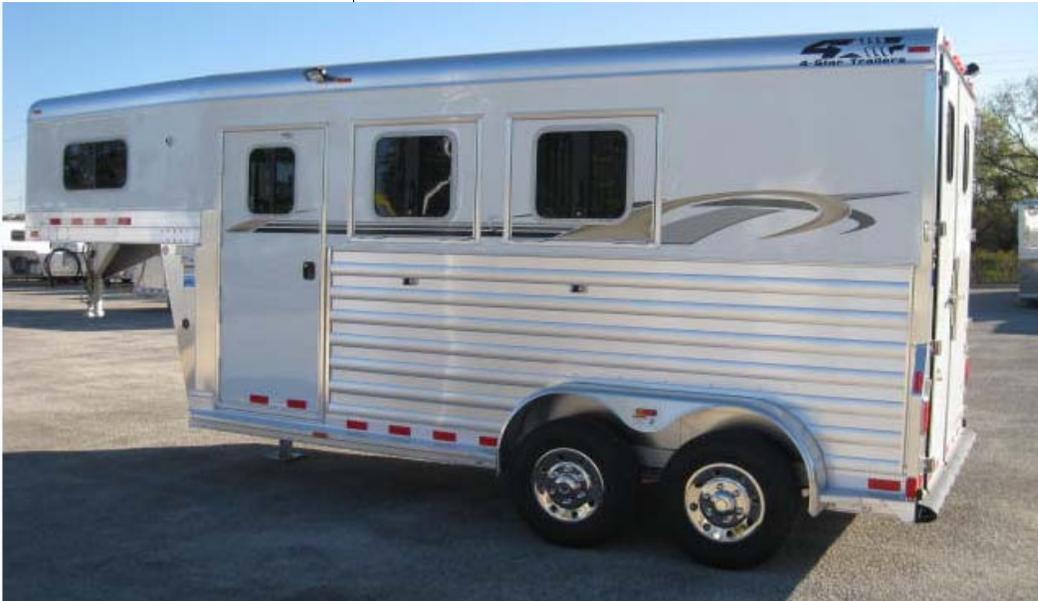
Fig. 3

and extending the side skins right up to the door openings, the jamb then overlaps the side skins all around them when it is welded to the trailer frame. This eliminates the exposed aluminum which had always

surrounded our doors and, contrary to what some have opined, actually strengthened our trailers because we maintained the same frame members around the door openings and added strength to those members by welding the door jamb to them. (See Fig. 3)

The newly developed doors, assembled using the adhesive, were far superior to the previous designs. The bonded doors were stronger, stiffer, and more water resistant. In carefully controlled testing, they proved to be over 400% stronger than the previous doors. The elimination of welds and their accompanying heat warp created a much flatter door. The elimination of rivets, which had been used to attach the aluminum skin, made for a much cleaner appearance.
