4-STAR TRAILERS - A WOLF IN SHEEP'S CLOTHING?

Butch Patchell, Director of Research & Development, 4-Star Trailers, Inc.

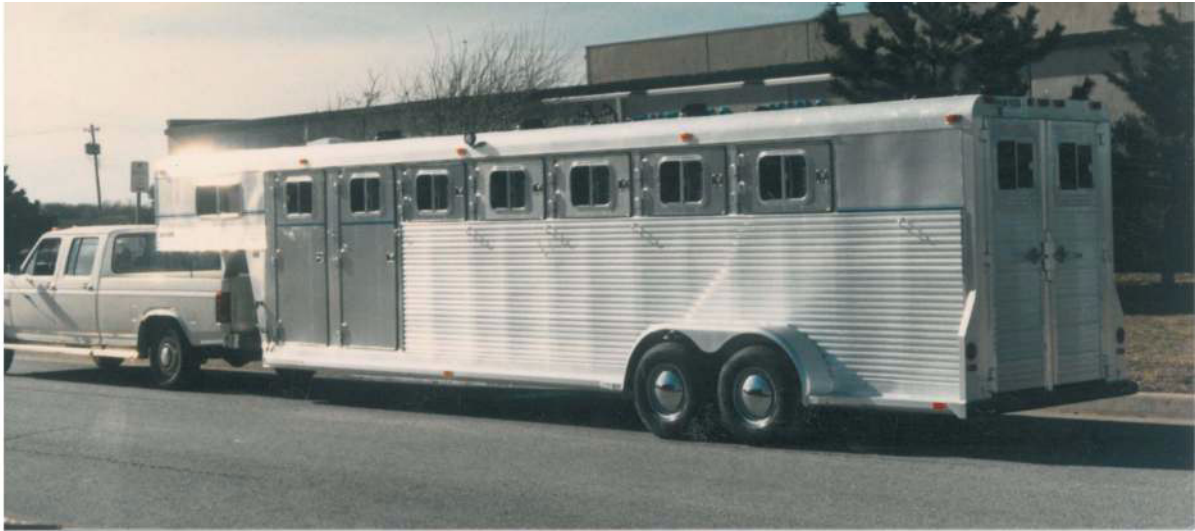
Fig. 1

The entire exterior of those trailers were rife with scars and distortions caused by the intense heat associated with welding. (See Fig. 1) The side walls were lined with corrugated slats that displayed the torture of MIG welds in the form of heat warps and burn throughs. The aluminum panels above the slats were covered in heat tracks where they were welded to the side posts.

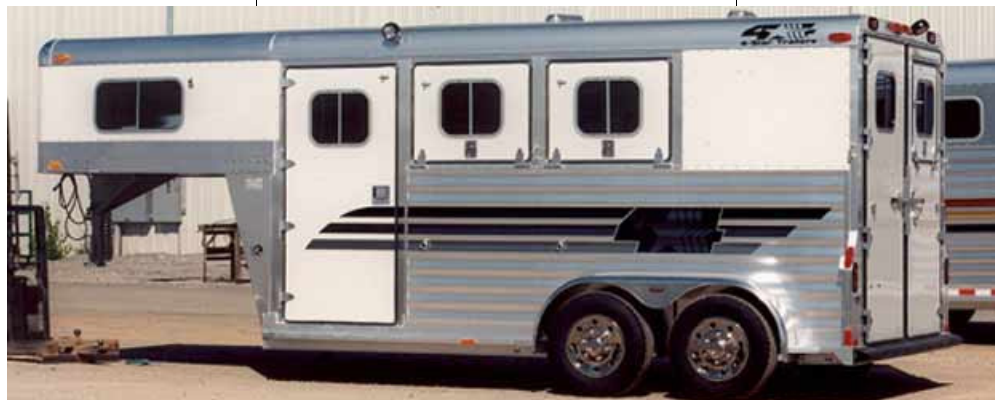
Fig. 2

At this time, the side skins overlapped the side posts around doors and windows leaving a large area of each post visible. (See Fig. 2) We needed this area of the side posts to be visible and accessible because we were still welding our door hinges to them. We didn't like the appearance of all this bare aluminum because we felt it now looked crude in contrast with the clean looking slats and side skins.

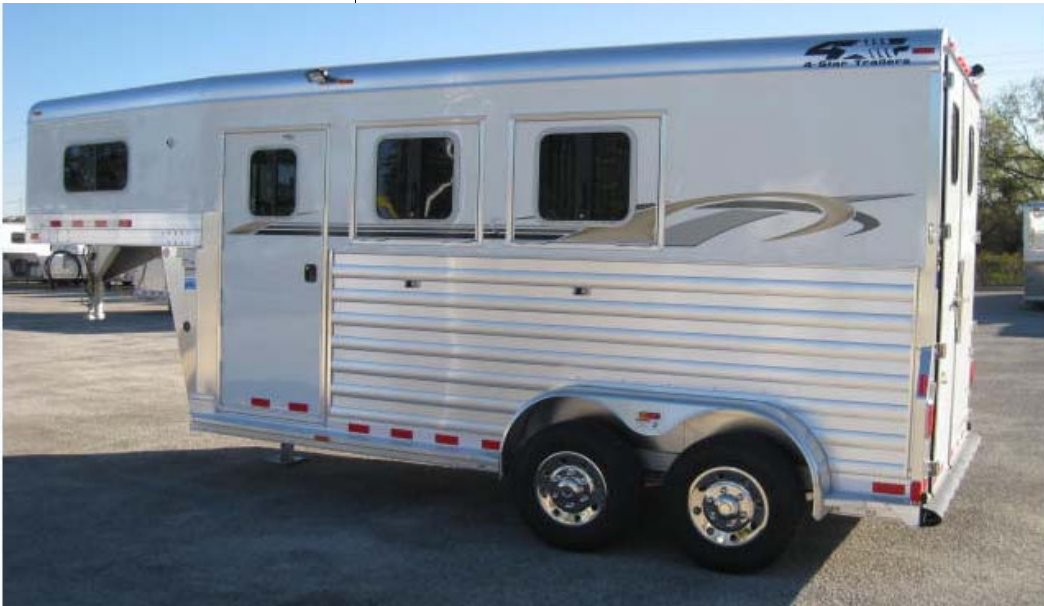
Fig. 3

surrounded our doors and, contrary to what some have opined, actually strengthened our trailers because we maintained the same frame members around the door openings and added strength to those members by welding the door jamb to them. (See Fig. 3)

We redesigned our exterior doors after experimenting with a structural adhesive from the Lord Corporation with the reputation of being as strong as a MIG weld in certain applications. By pre-hanging the doors in a jamb

and extending the side skins right up to the door openings, the jamb then overlaps the side skins all around them when it is welded to the trailer frame. This eliminates the exposed aluminum which had always
